# HISTORIC STRUCTURE REPORT

**MCCAMMON LOG HOUSE**  
79 Lanchester Road, Honey Brook Township,  
Chester County, Pennsylvania

November 2018

RGA, Inc.  
259 Prospect Plains Road, Building D  
Cranbury, New Jersey 08512

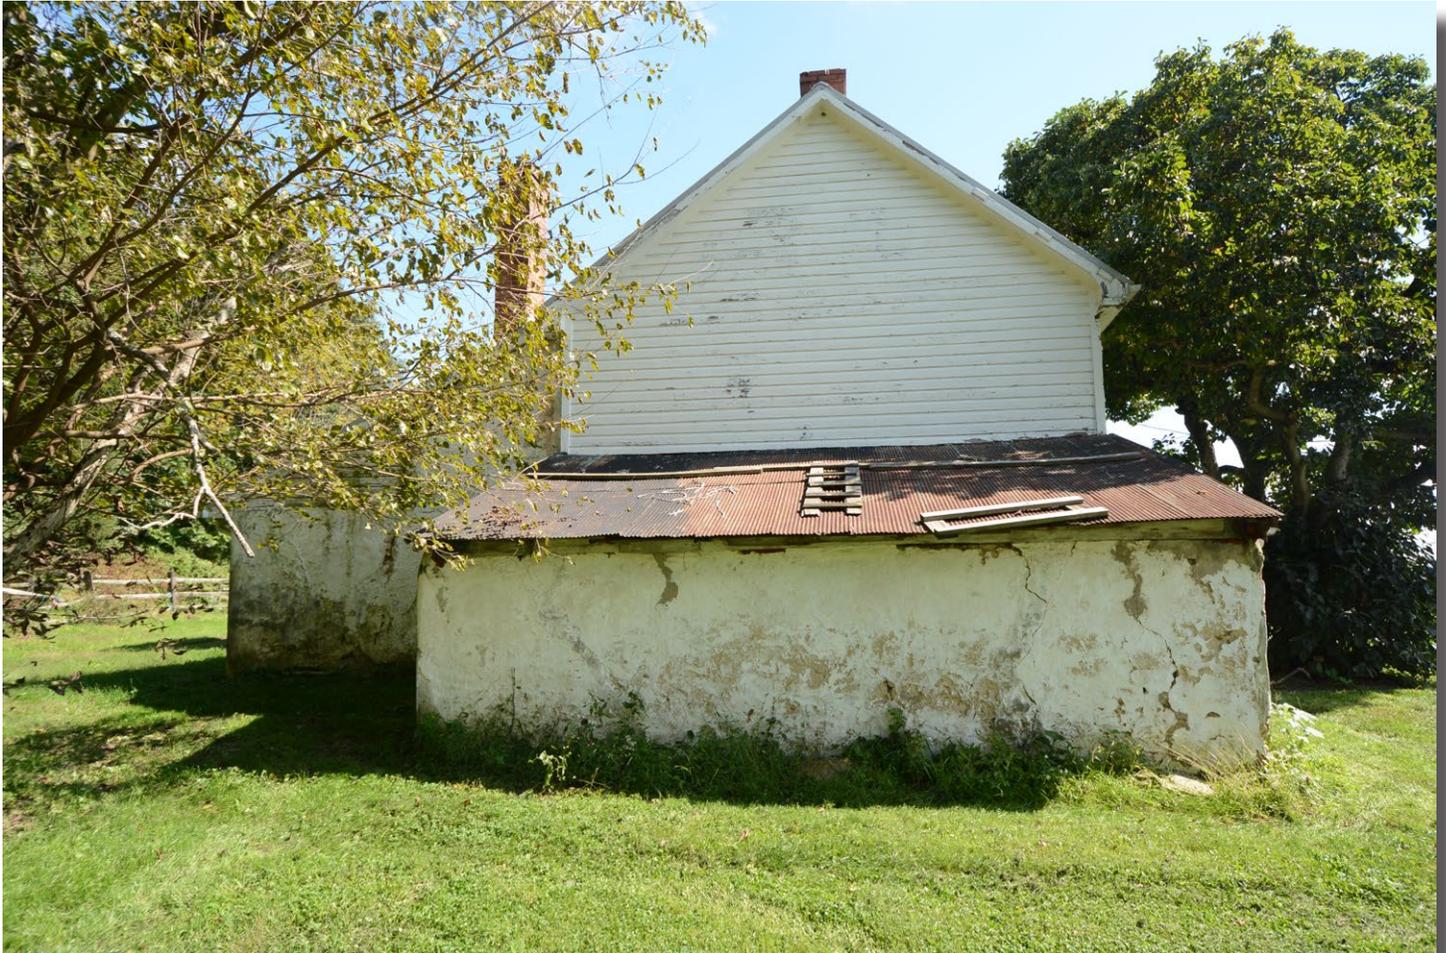
Plate 3.11: McCammon Log House, west elevation.

The circa 1802 stone shed addition covers the first floor of the log core's west elevation. The small brick chimney is not original.

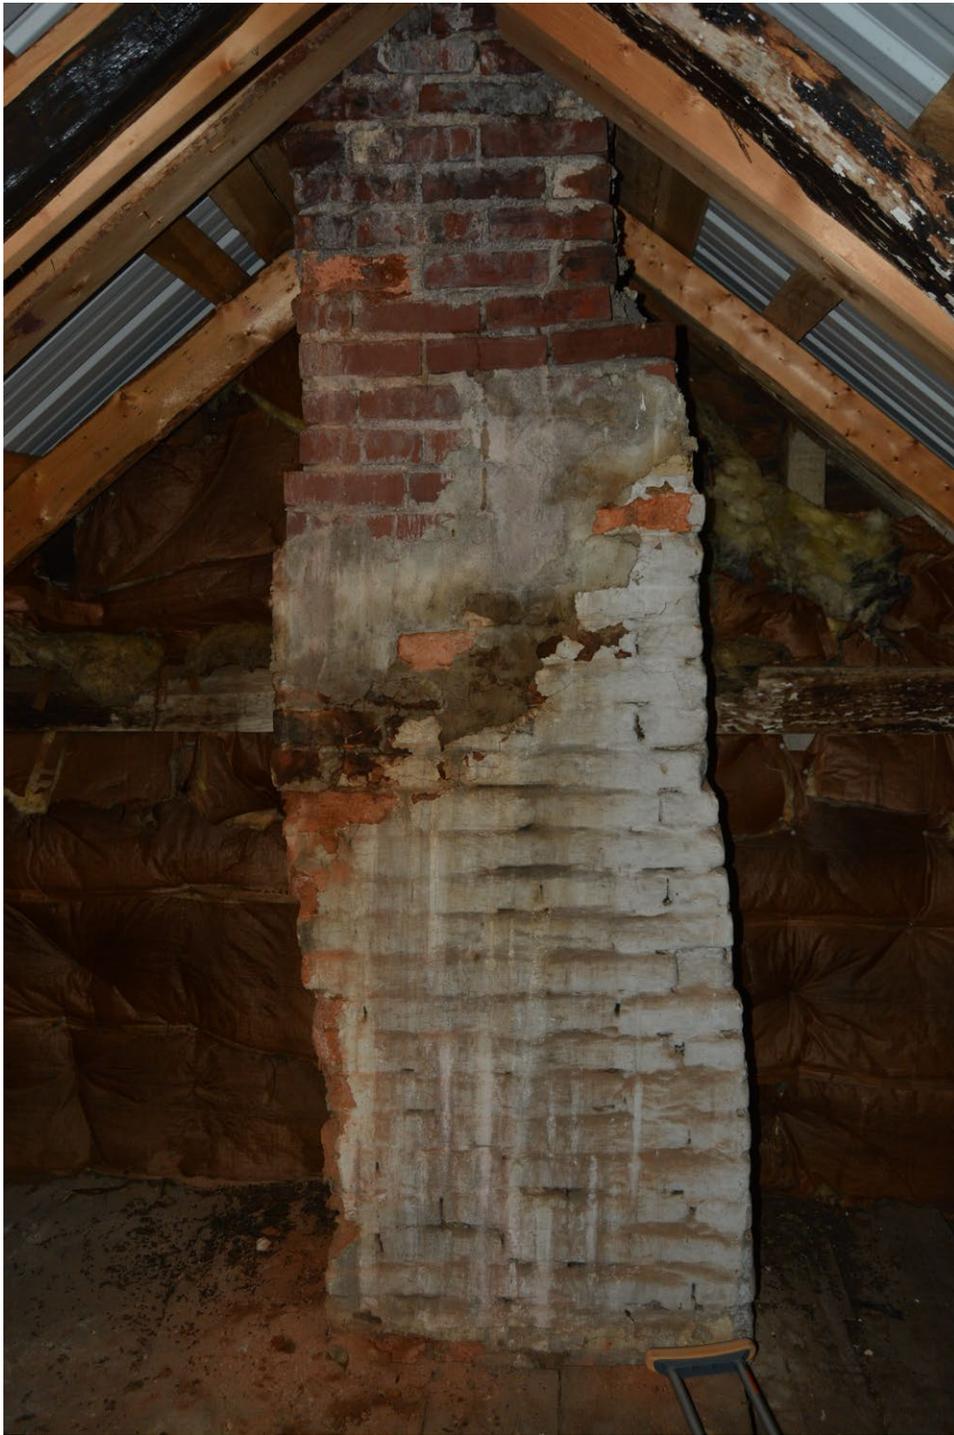
Plate 4.42: Log Core, attic, showing chimney.

The upper portion of the chimney has been rebuilt; the original brick (whitewashed) is in poor condition.
