# HISTORIC STRUCTURE REPORT

**MCCAMMON LOG HOUSE**  
79 Lanchester Road, Honey Brook Township,  
Chester County, Pennsylvania

November 2018

RGA, Inc.  
259 Prospect Plains Road, Building D  
Cranbury, New Jersey 08512

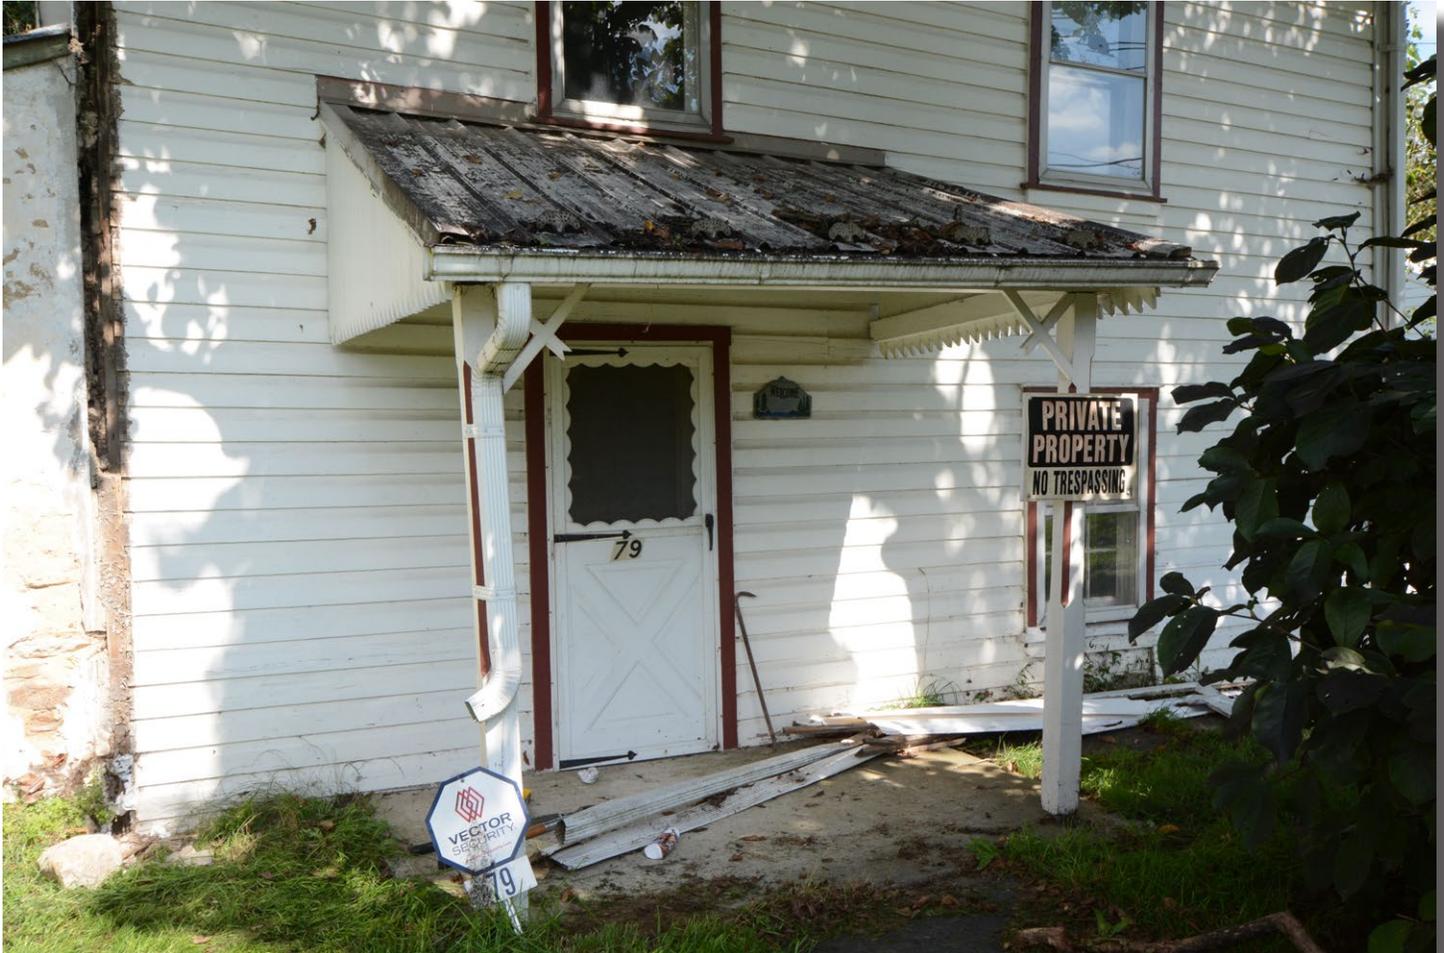
Plate 3.5: Log Core, south façade, showing front entrance and porch.

Note the “saw tooth” decorative woodwork under the shed roof. This is also found on the hood over kitchen door, indicating it was added in the mid-twentieth century.

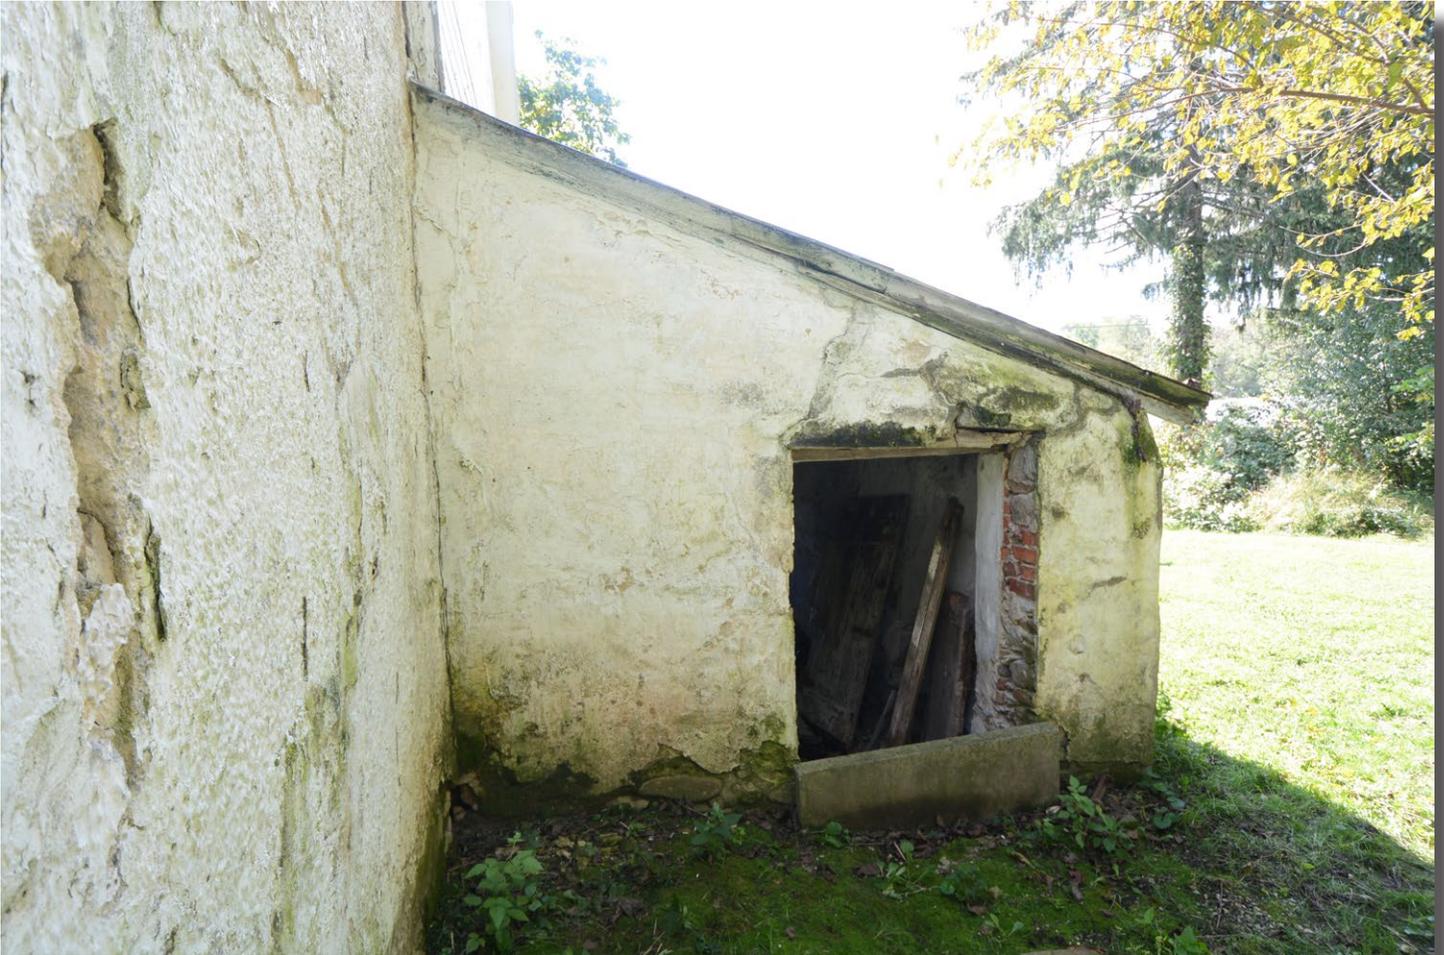
Plate 3.13: Circa 1802 stone shed addition, north elevation.

The door framing and door have been removed; the large stone in front of the doorway directs water away from the building envelope.

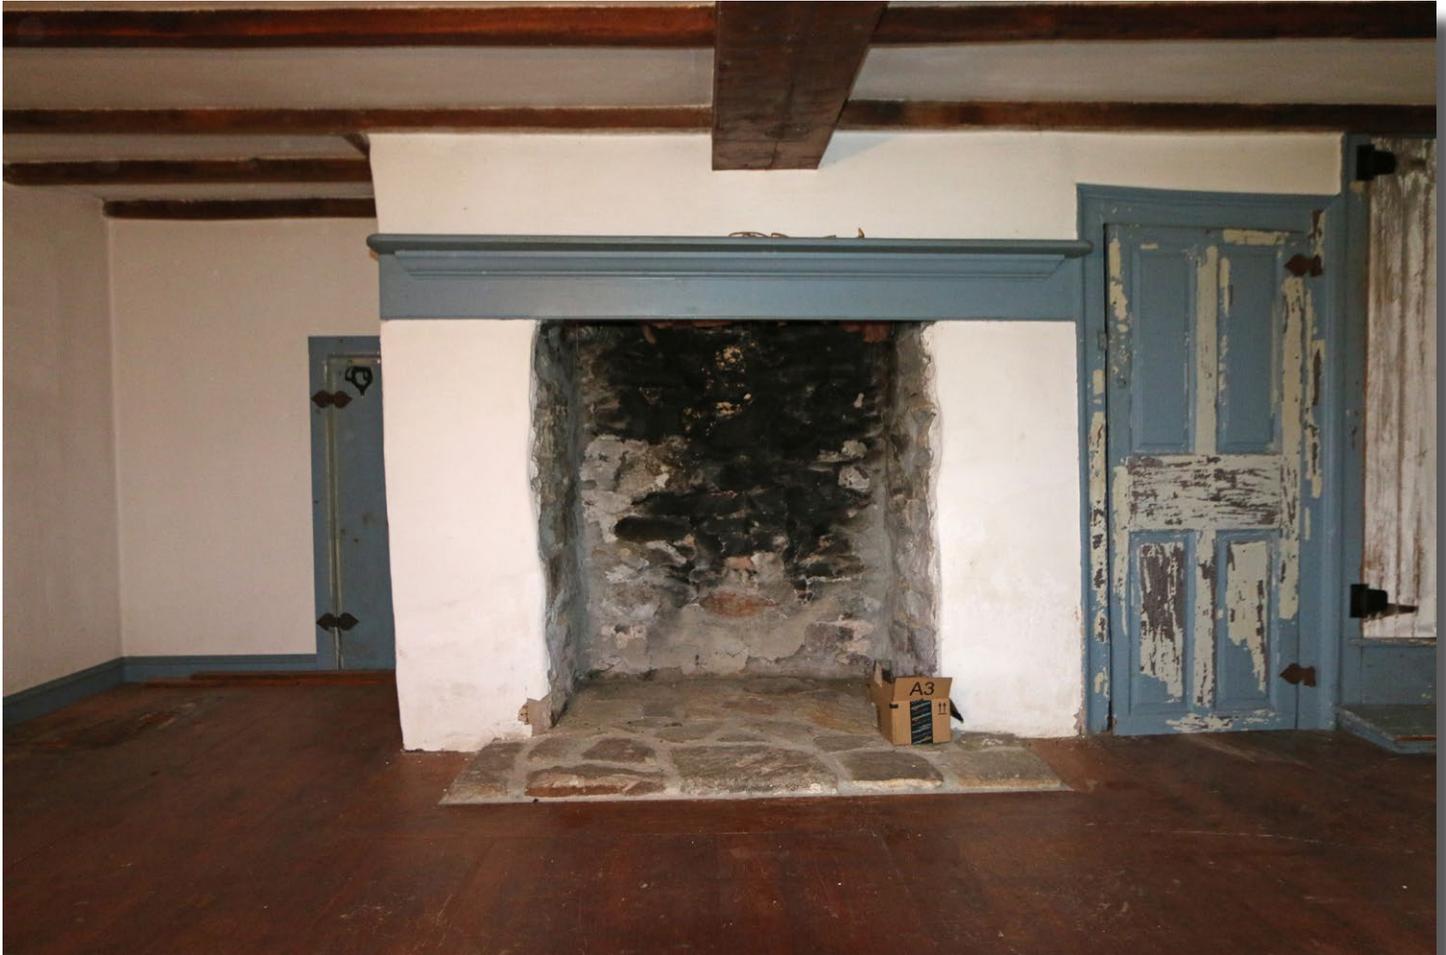
Plate 4.7: Log Core, first floor, living room, showing former kitchen hearth on west wall.

The mantel and flooring are not original.

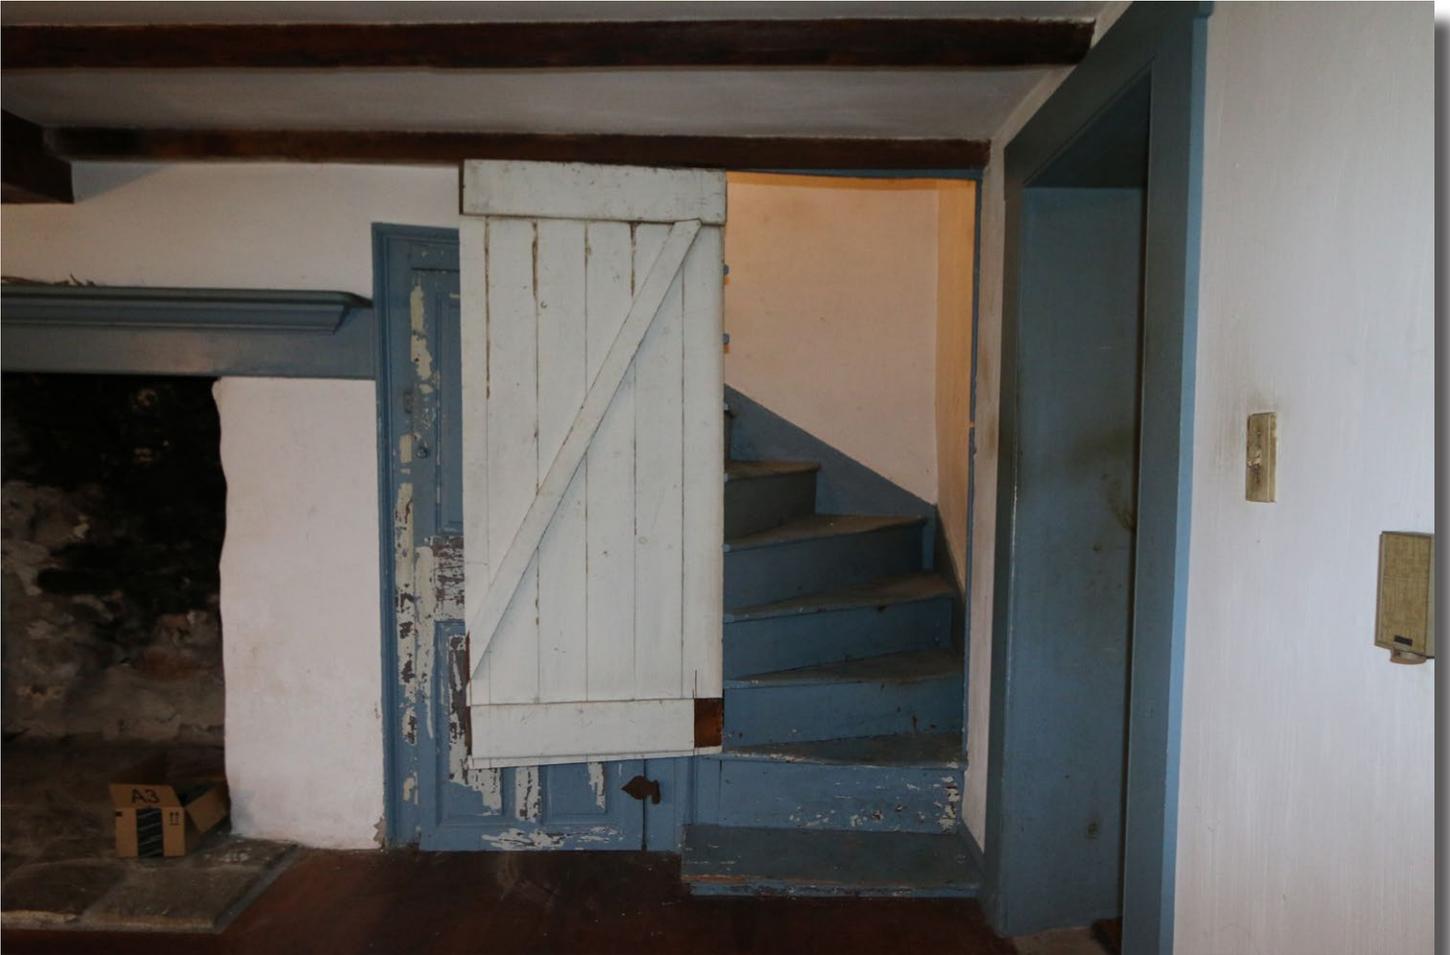
Plate 4.9: Log Core, first floor, living room, showing stairs to second floor.

Note that the lower step is unusually shallow.

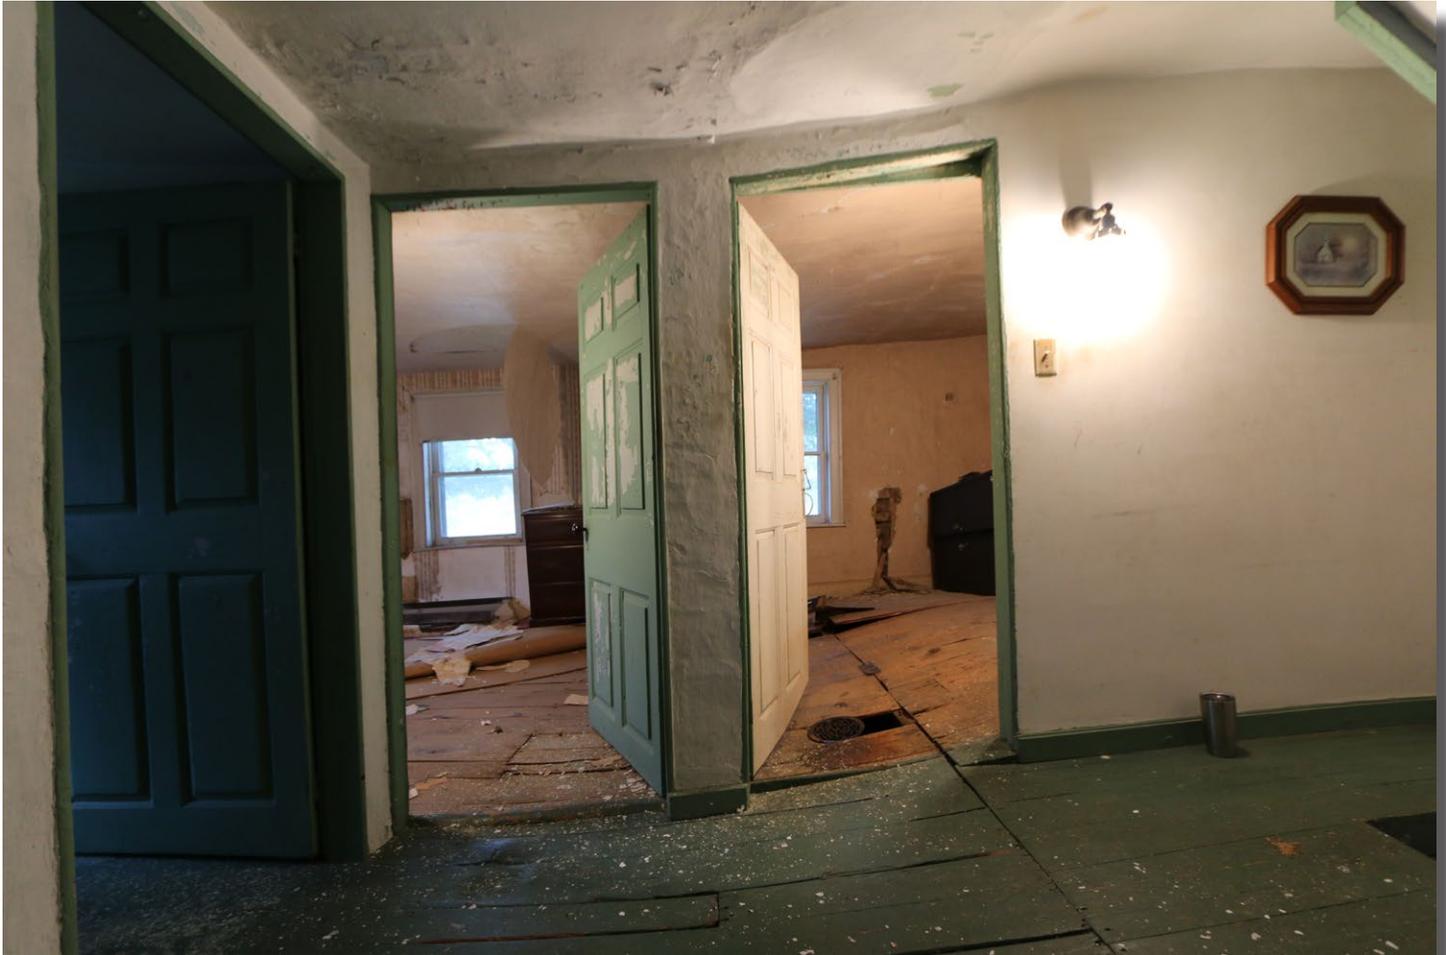
Plate 4.16: Log Core, second floor, hall, another view from hall facing the doorways into bedrooms.

The settling of the house is noticeable both at the floor level and the angled door openings.

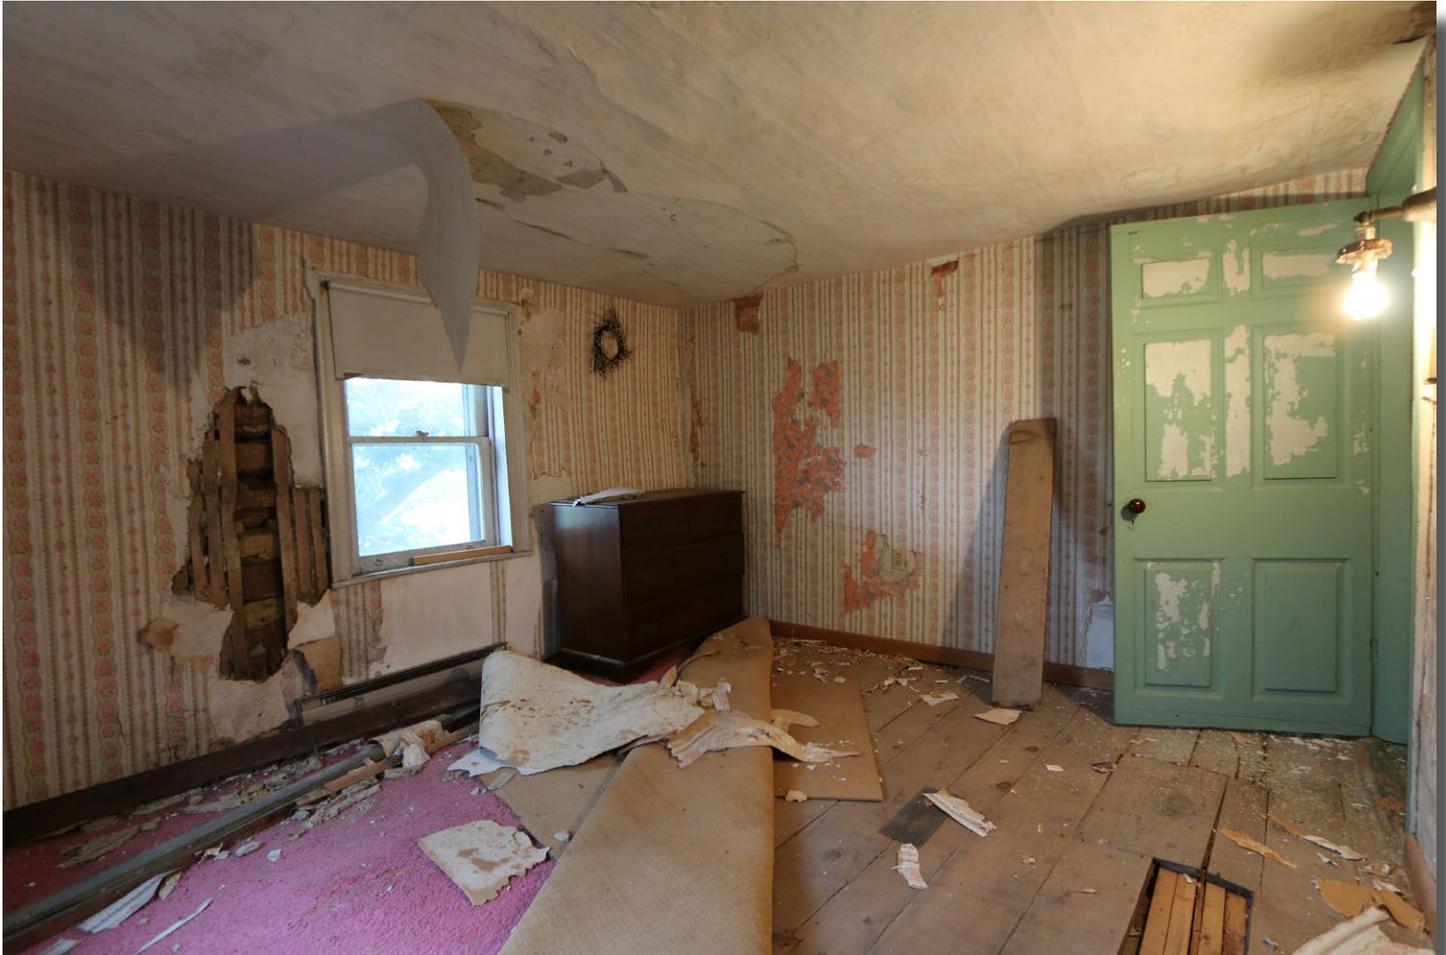
Plate 4.25: Log Core, second floor, southeast bedroom, south and west walls.

Note section of removed flooring in right foreground, showing new main support beam made out of modern lumber.

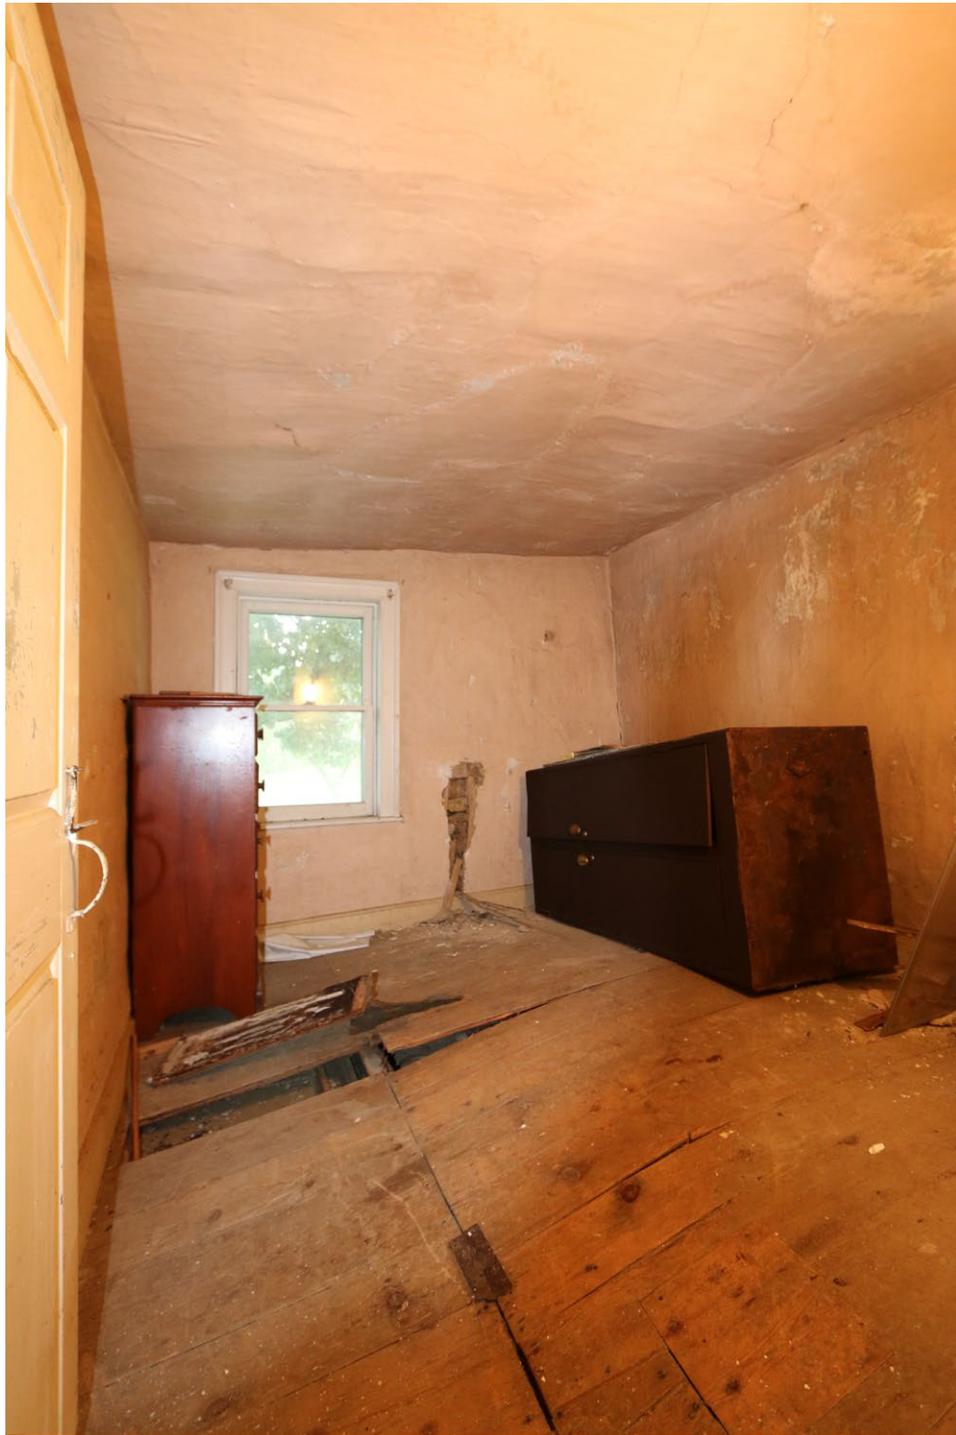
Plate 4.30: Log Core, second floor, southwest bedroom, as seen from bedroom door.

Note severe settling of flooring which has made the room uninhabitable.

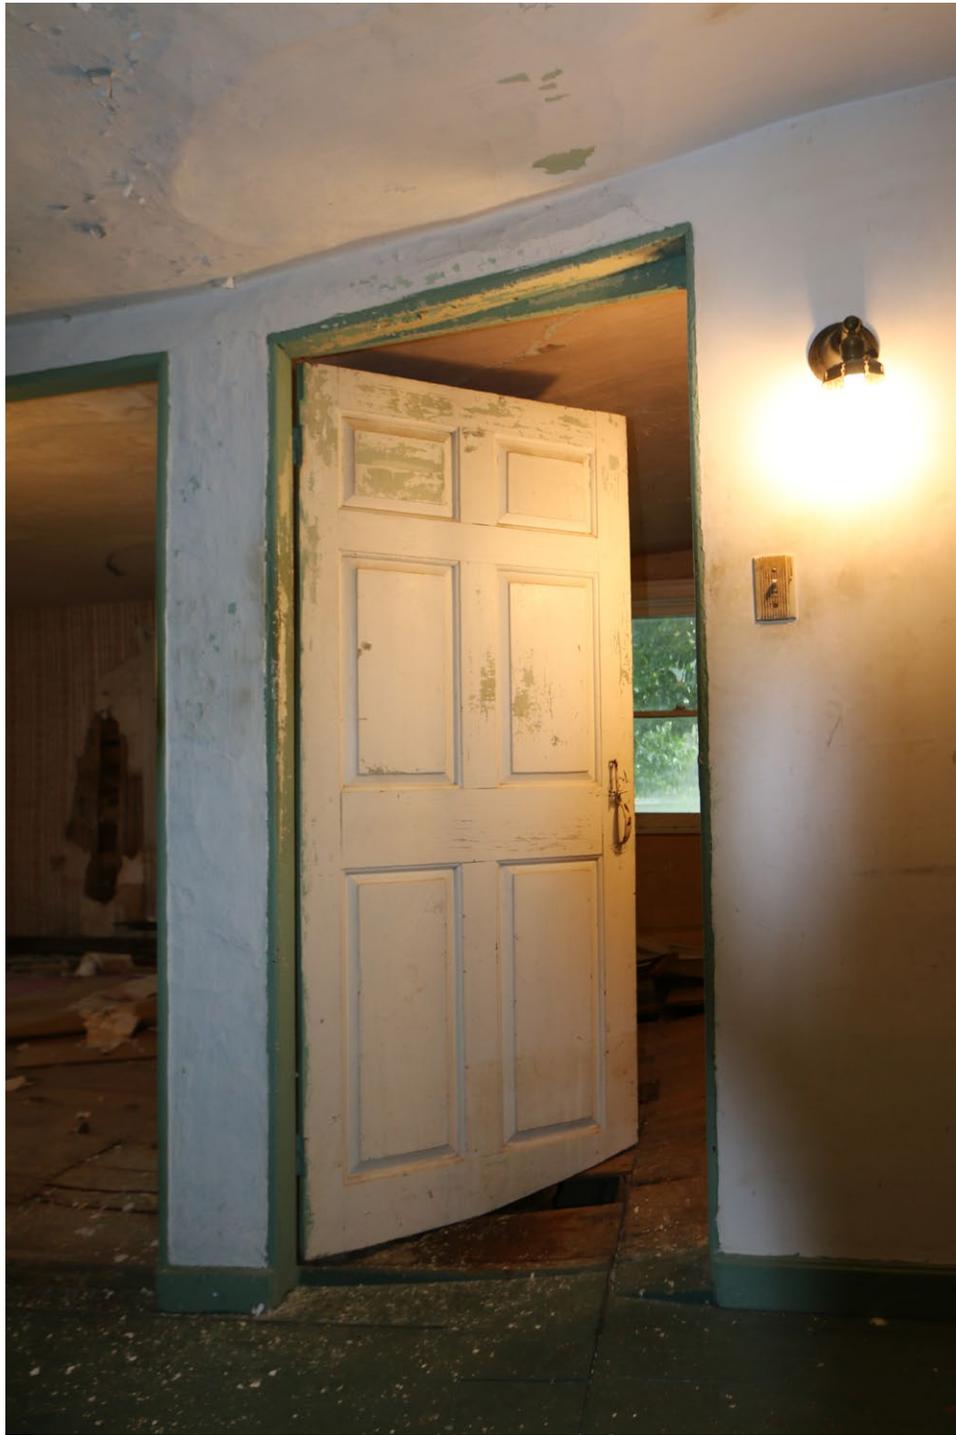
Plate 4.33: Log Core, second floor, southwest bedroom, detail of original door from hall.

Note the lower rail on the door has been shaved to fit the sloping floor inside.

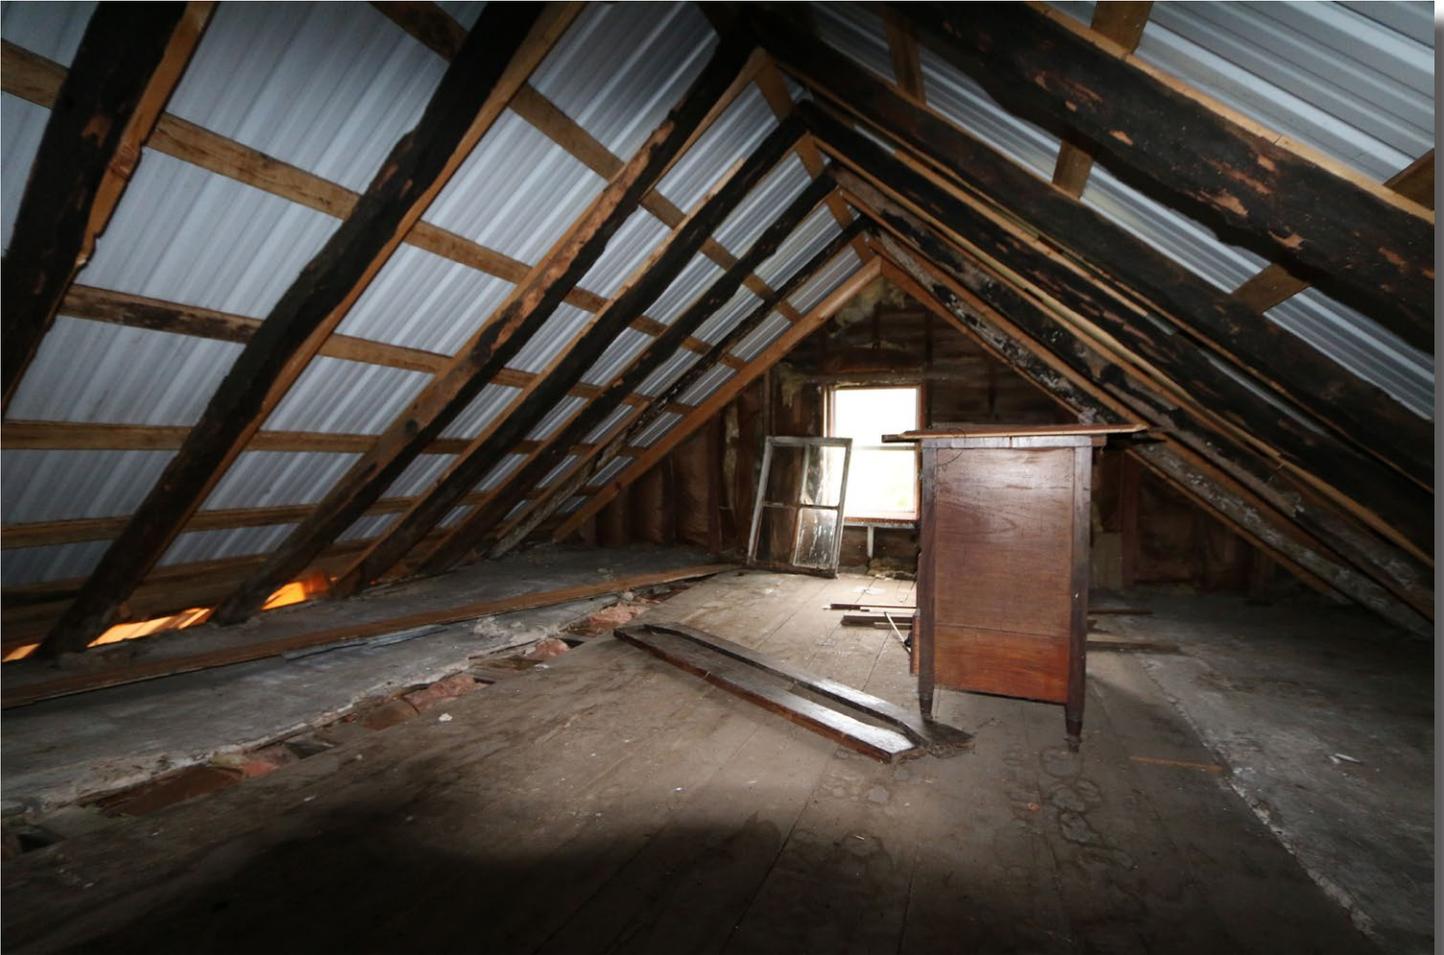
Plate 4.38: Log Core, attic, facing east from the stairs.

Note the cement fireproofing has been removed in the center to enable modern insulation to be placed between the floor joists. Overhead, the rafters are scarred from a fire. The metal roofing material above is modern.

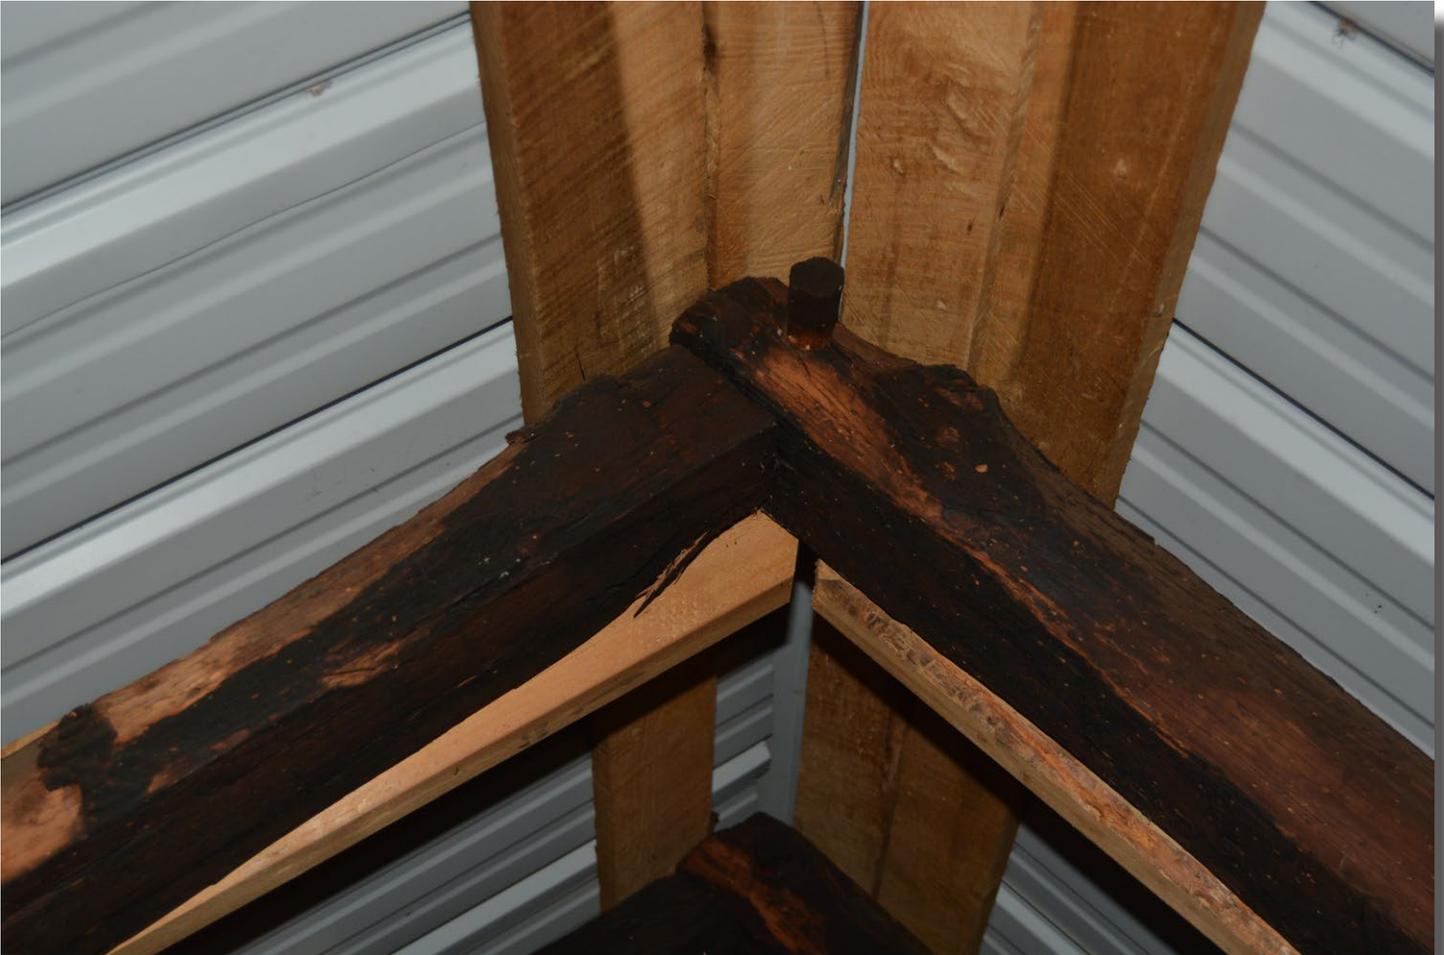
Plate 4.40: Log Core, attic, detail of the tongue-and-fork notch of the rafters.

The rafters are charred from the fire and strengthened through “sistering” (joined to new lumber).

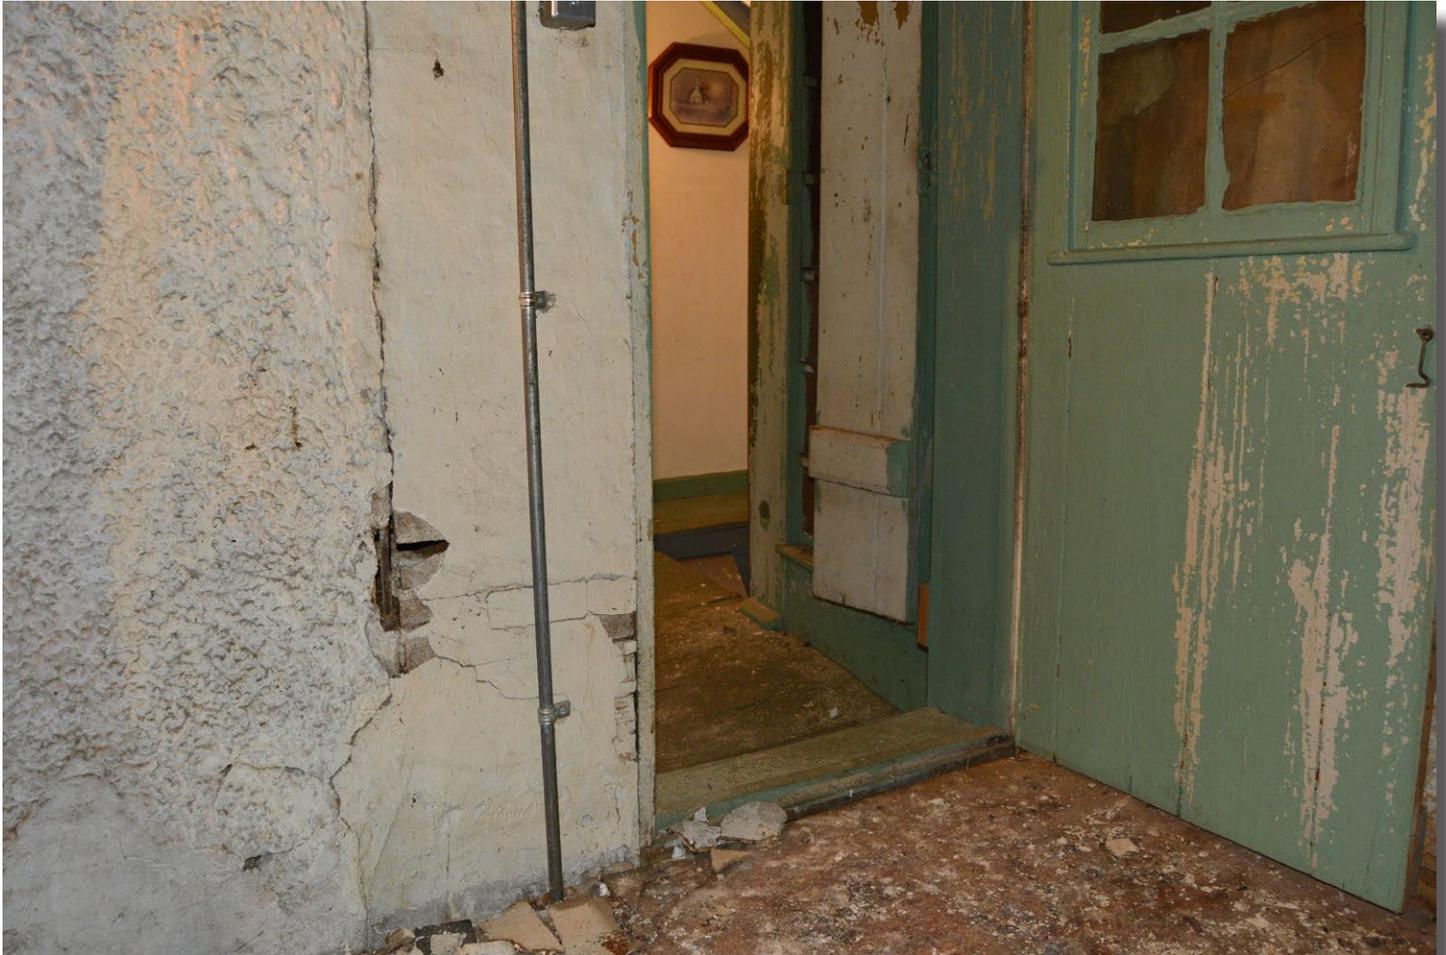
Plate 4.58: Circa 1839 Rear Addition, attic, detail of the hall to attic doorway.

The smoother stucco indicates that the original entrance was larger.

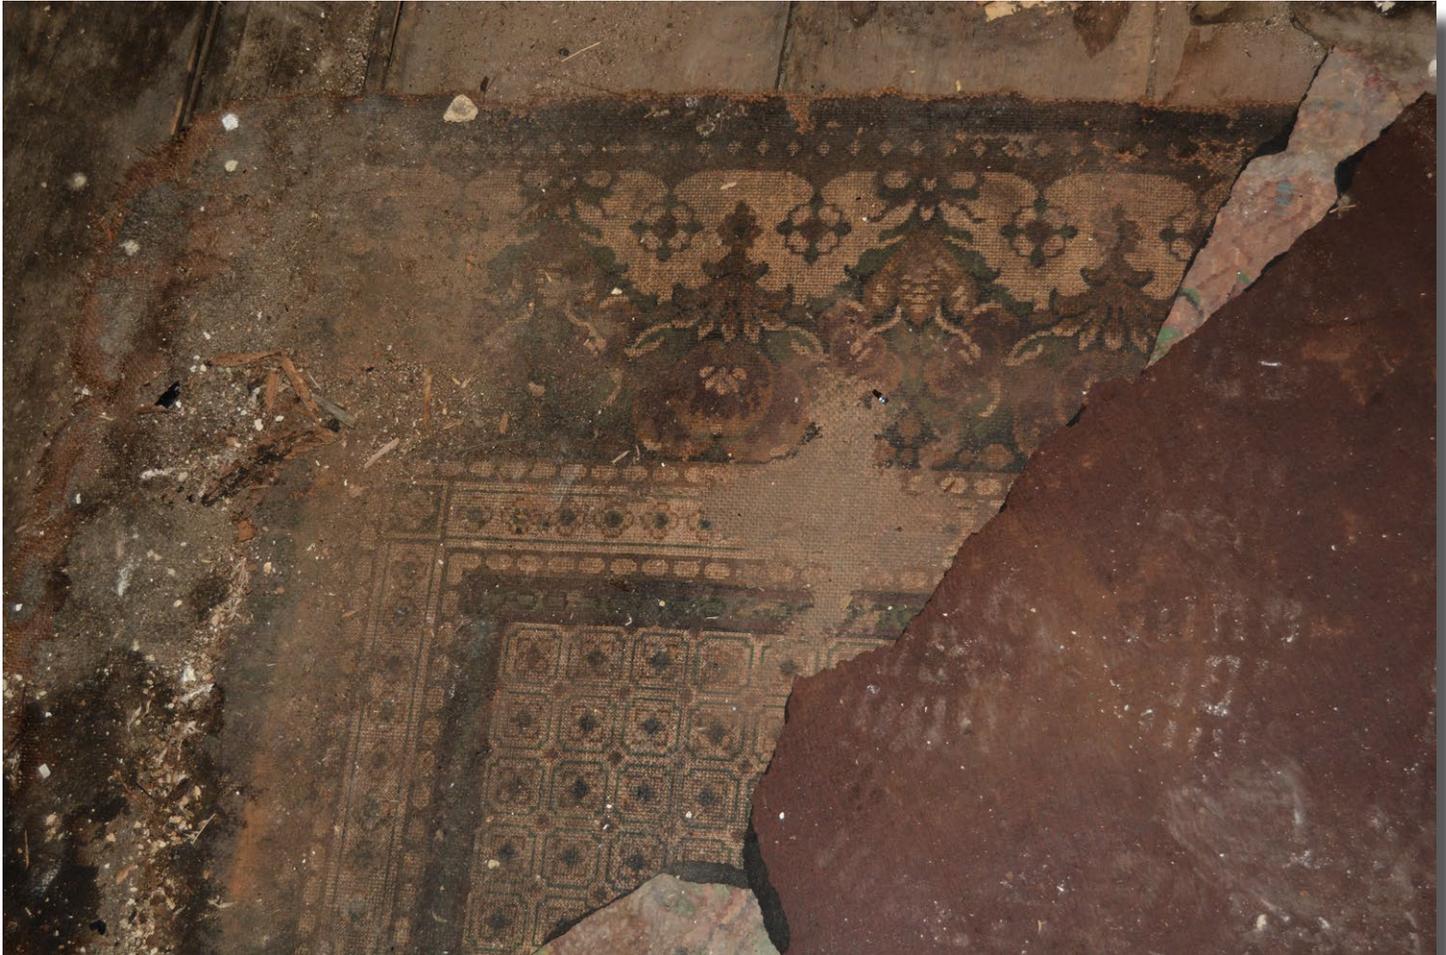
Plate 4.59: Circa 1839 Rear Addition, attic, showing remnant of oil cloth floor treatment on wooden attic floor.

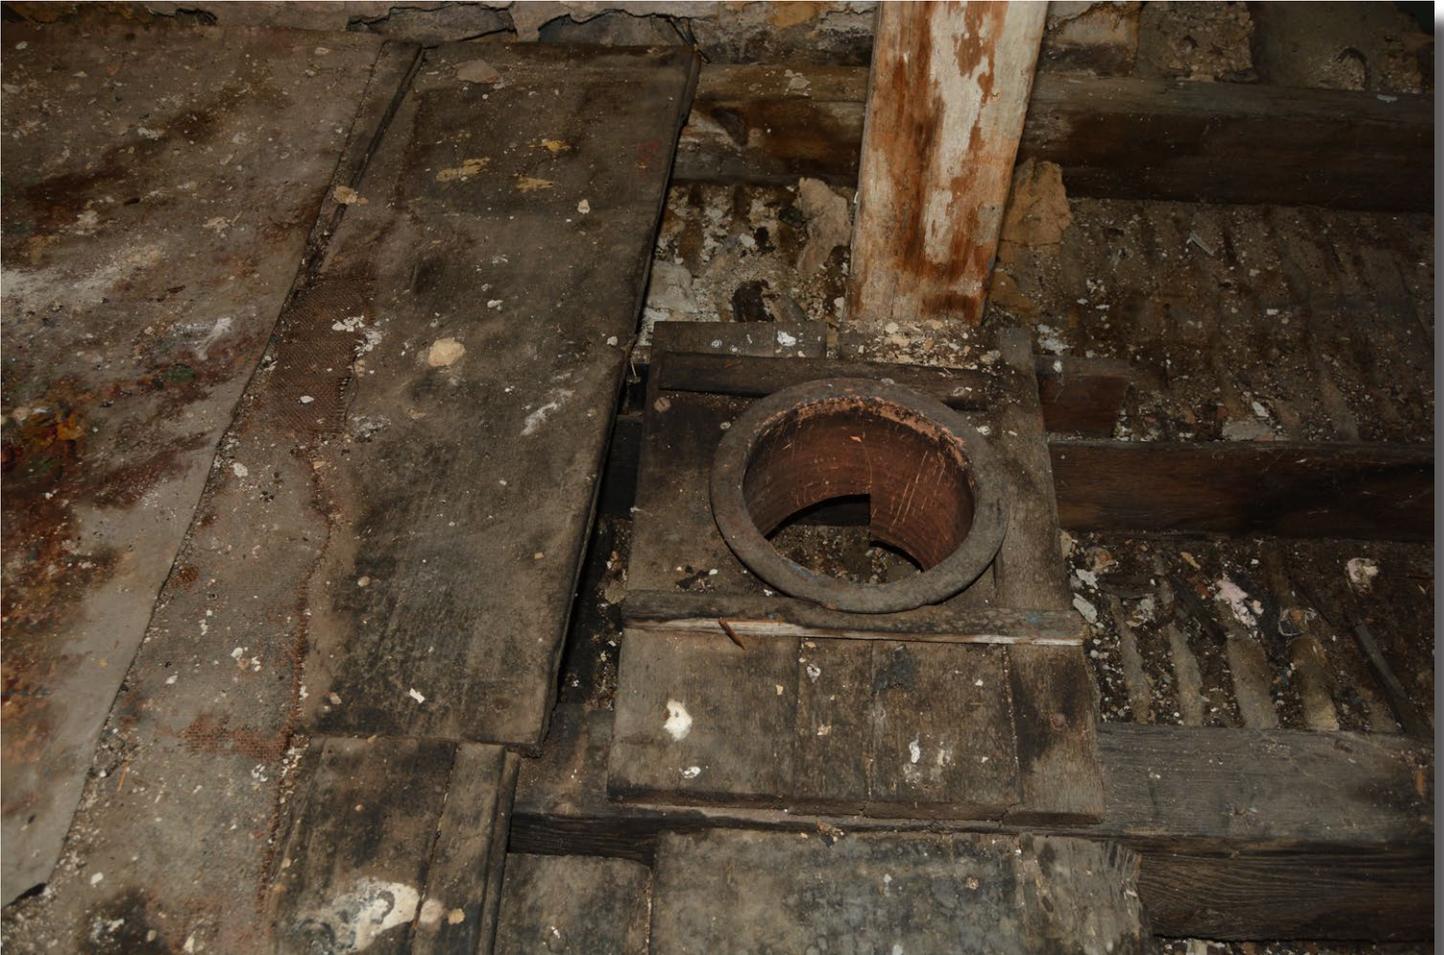
The section’s attic space is accessed from the second floor hall of the log core (Plates 4.53 to 4.60; see Figure 4.2). It is a single prism-shaped space that occupies the entire upper level of the section. Above, the original undressed rafters survive intact, although they display charring on their lower side that points to the fire that took place in the house at an undetermined time. The rafters have been strengthened through the process called “sistering,” in which new 2x4 boards have been nailed along their sides for additional support. The underside of the corrugated tin roof is visible between the rafters. On the end walls, original studs survive intact, including a set on the east wall that historically supported an attic window that has been sealed on the exterior but survives on the inside. The exterior wall of the log core was stuccoed; lath was nailed vertically onto the logs, and a wire mesh was attached that supported the stucco. At the top of the wall, a portion of the original exterior cornice of the log core survives, though covered with stucco. The door accessing the space is located west of center on the wall, but markings on the stucco indicate that it was formerly located two feet further east than its current location (Plate 4.58). The west wall includes the chimney flue for the section, which is encased in the southwest corner. The floor is covered with wide tongue-and-grooved boards running east/west. A small area of oilcloth survives in front of the door (Plate 4.59). A floor register formerly brought heated air from the room below, but the grate has been removed and the access below sealed, leaving the base for the grate (Plate 4.60).

Plate 4.60: Circa 1839 Rear Addition, attic, showing remnant of a floor register that formerly brought heat into the space from the first floor fireplace.

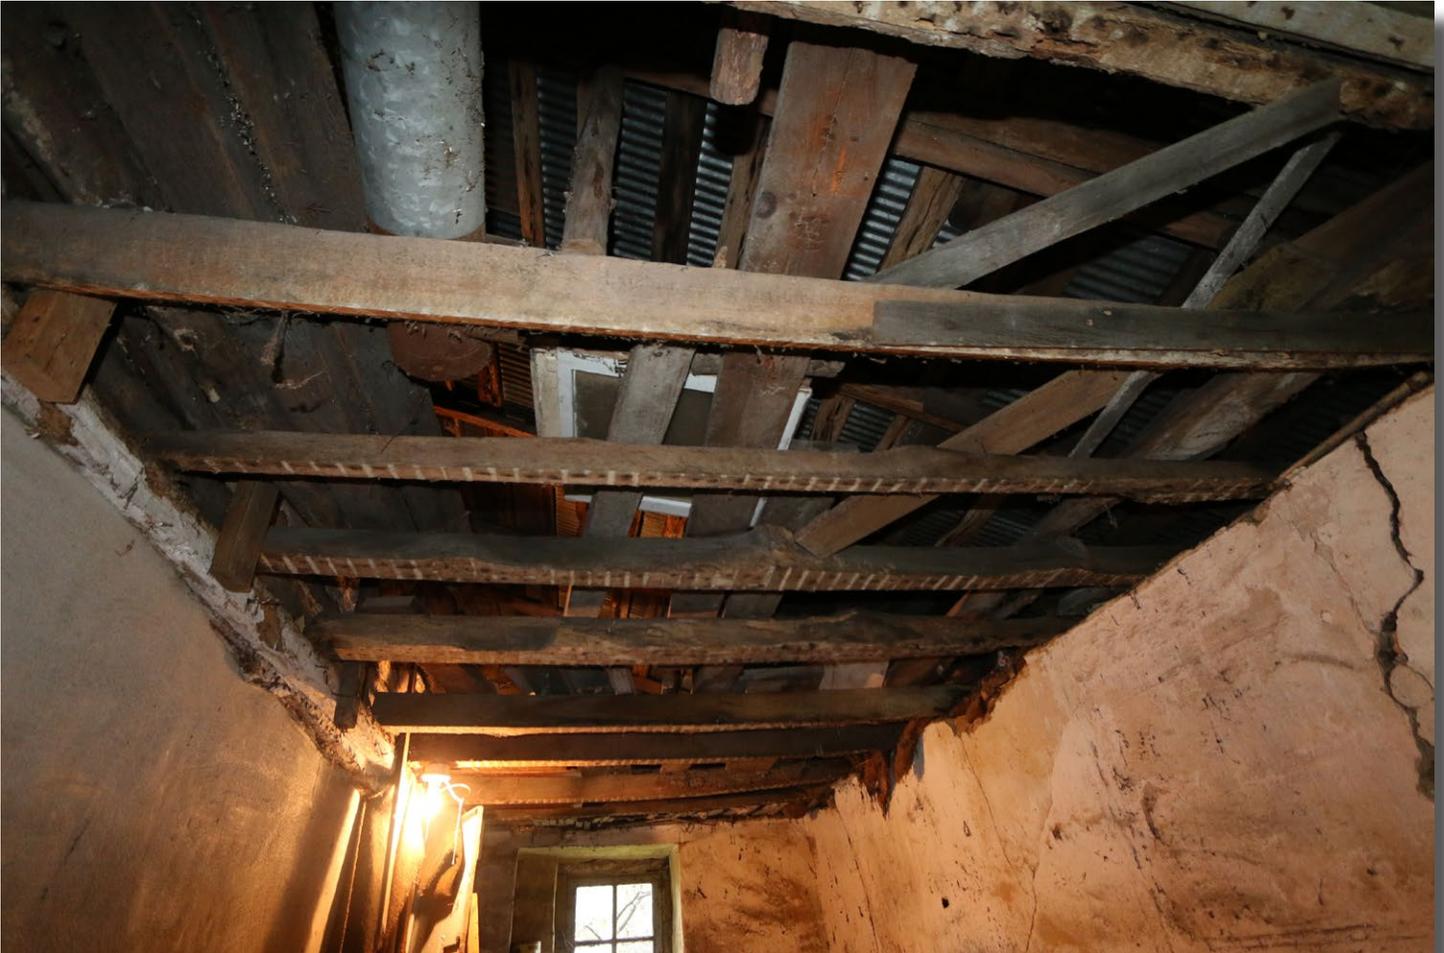
Plate 4.67: Circa 1802 Stone Shed Addition, interior, showing joists and rafters over the stone walls.

Markings on the lower side of the rafters indicate the space formerly had a plaster and lath ceiling.

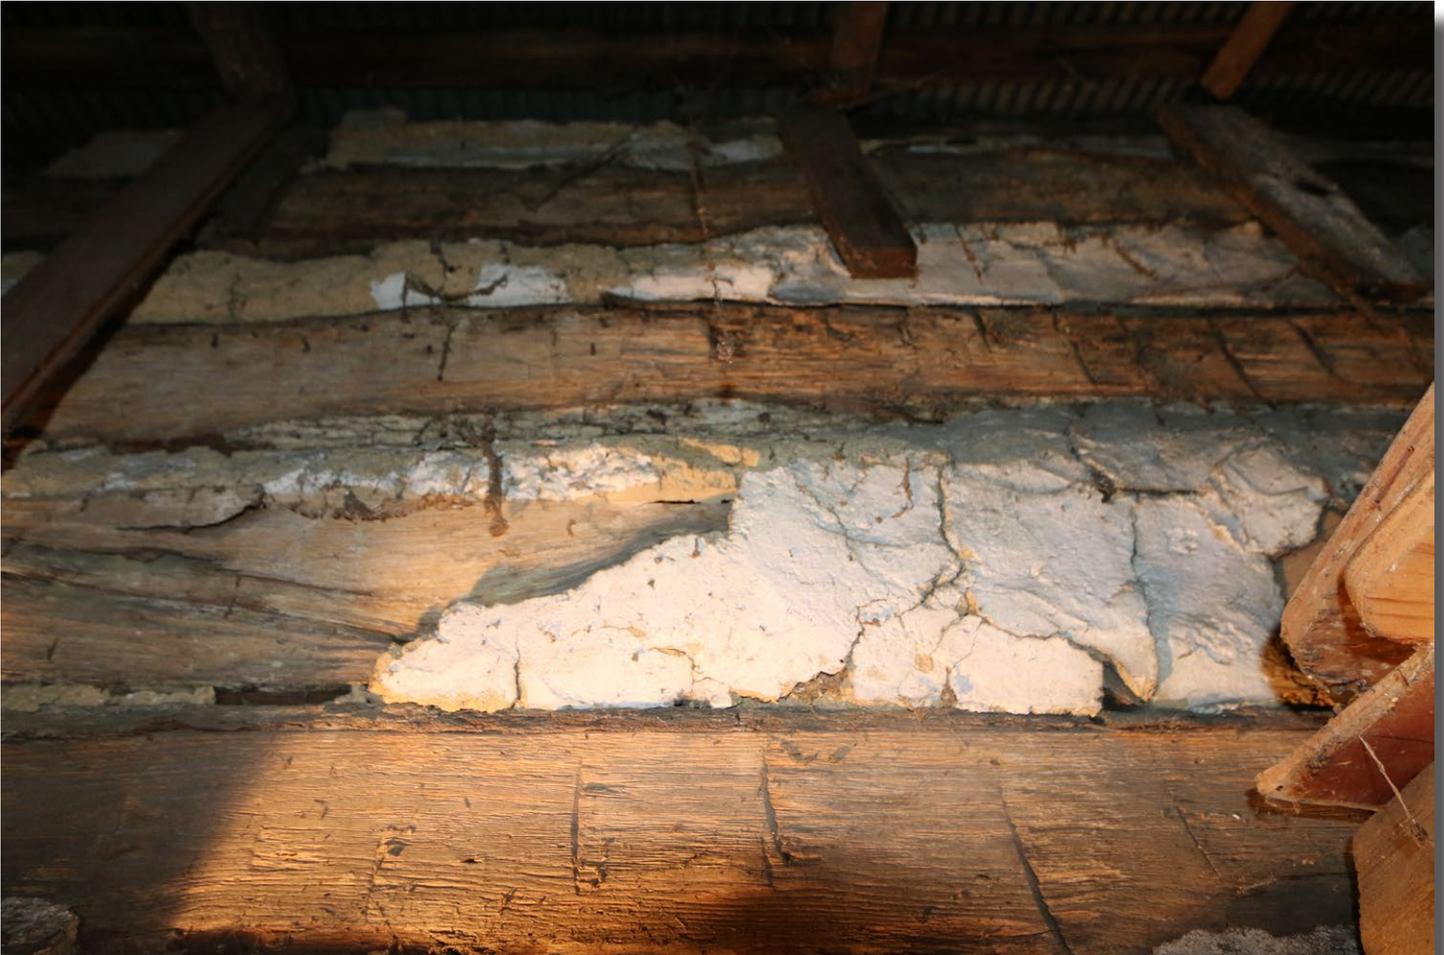
Plate 4.68: Circa 1802 Stone Shed Addition, interior, detail of the chinking on the west elevation of the log core.

Portions of the logs and chinking are covered with whitewashed stucco.
