# HISTORIC STRUCTURE REPORT

**MCCAMMON LOG HOUSE**  
79 Lanchester Road, Honey Brook Township,  
Chester County, Pennsylvania

November 2018

RGA, Inc.  
259 Prospect Plains Road, Building D  
Cranbury, New Jersey 08512

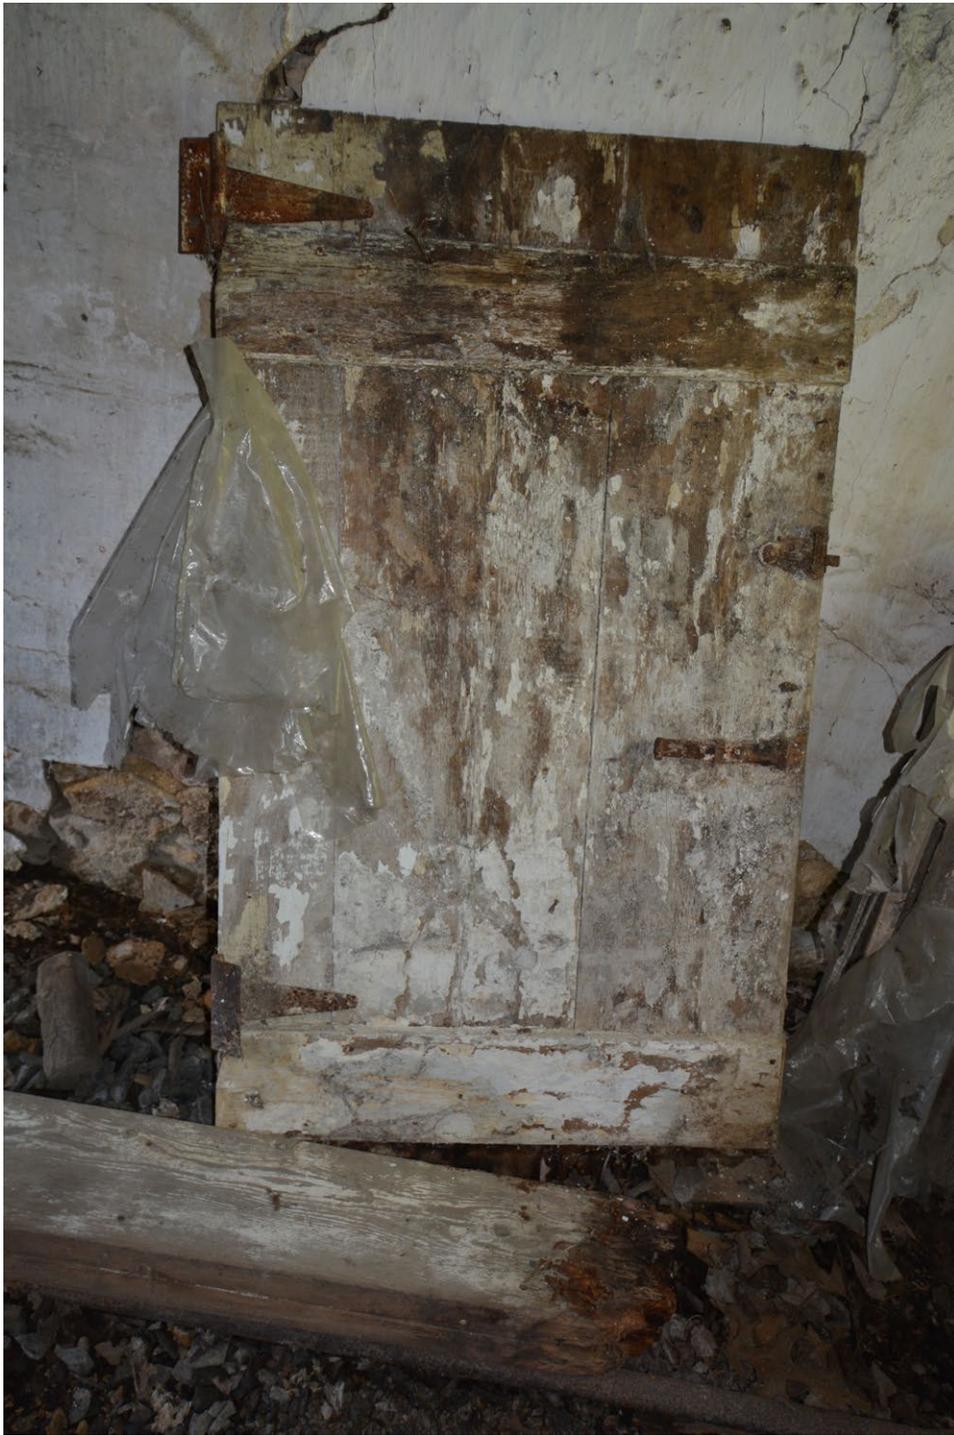
Plate 4.70: Circa 1802 Stone Shed Addition, interior, showing exterior batten door originally located on the north entrance to the stone shed addition.
